Case Study

Corrosion Cure – using outstanding anti-corrosive waterborne coat as part of paint system for maintenance

Goliath Leader

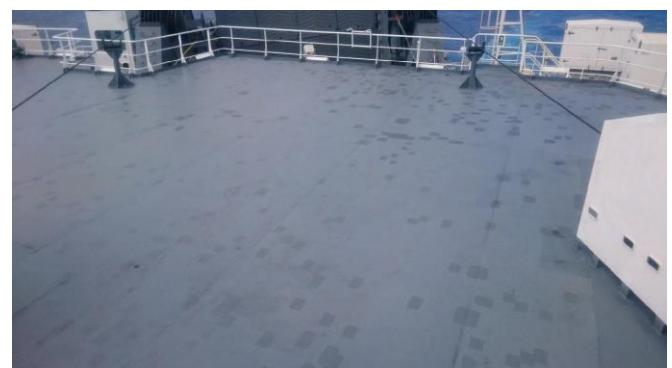
Upper deck after treatment

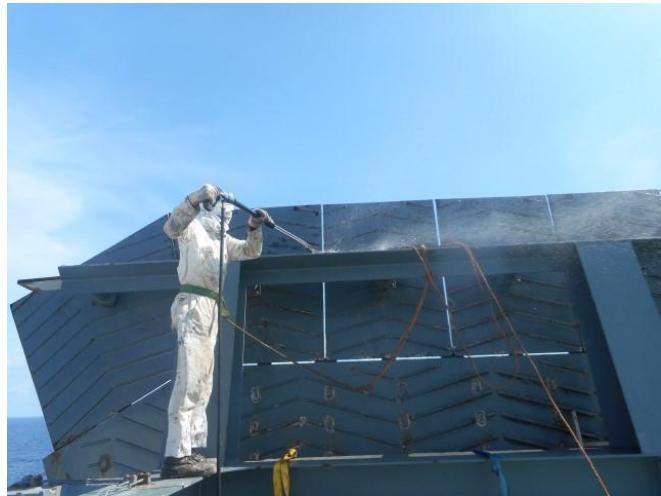
Vehicle Weather side ramp:

Surface preparation - high pressure water

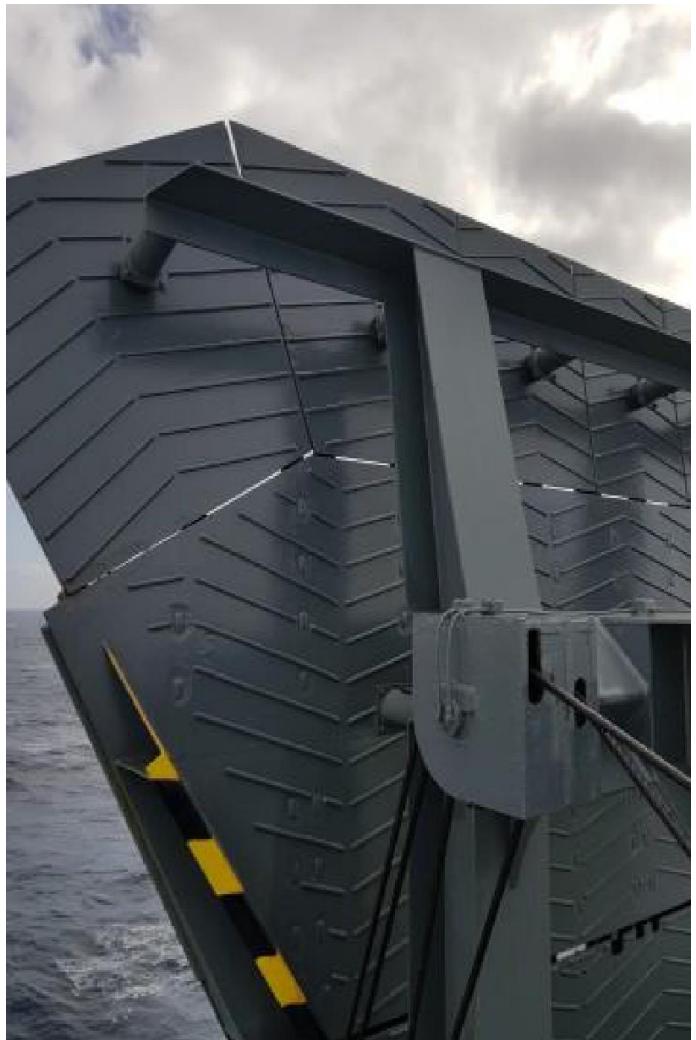
Vehicle carrier side ramp during maintenance
